TNO report**MT-RAP-2008-01066/mso | 2****Quality of PVC sewage pipes in the Netherlands**

Date	April 2, 2008
Author(s)	J. Breen
Assignor	BureauLeiding Loire 150 2491 AK Den Haag
Project number	033.12953
Number of pages	25 (incl. appendices)

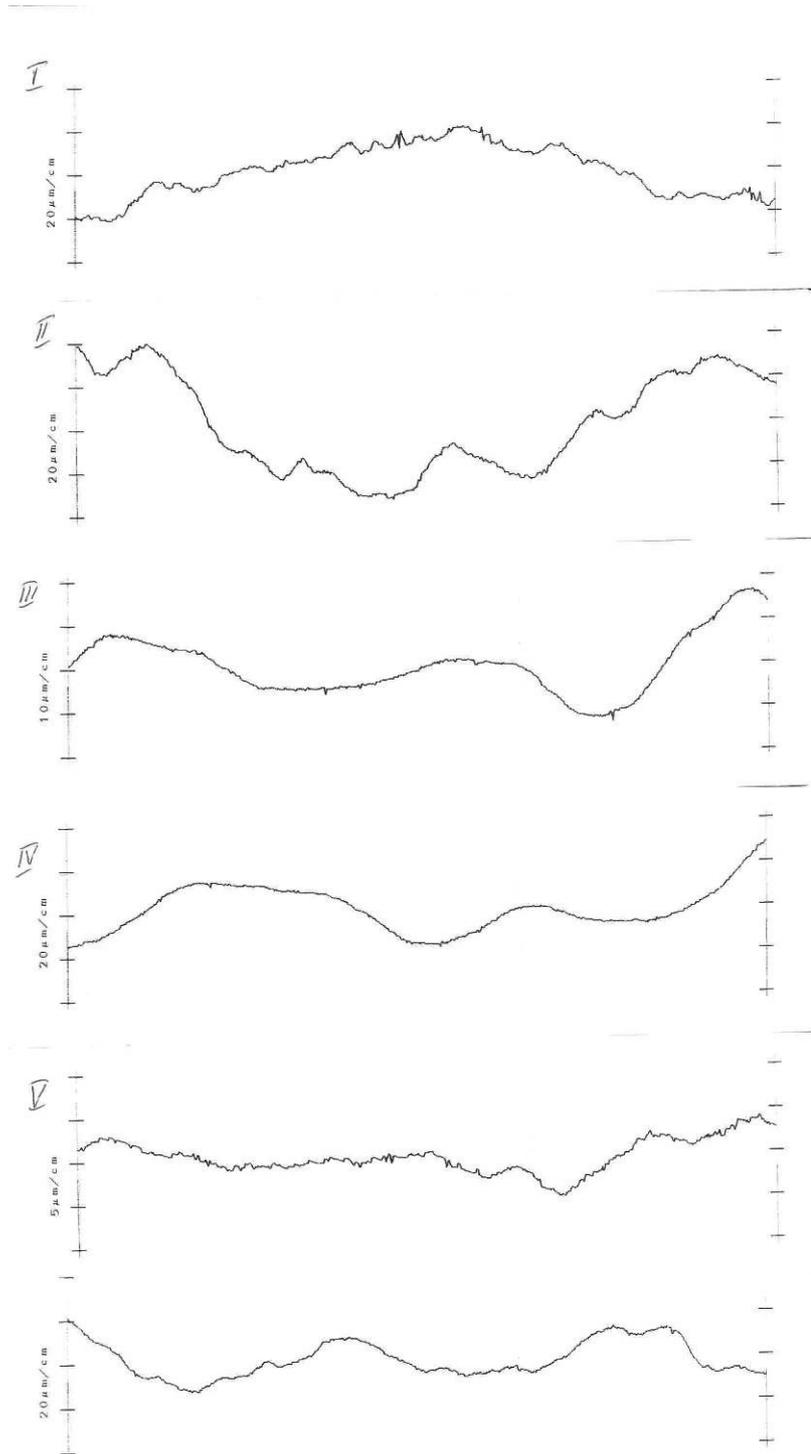
Moreover, a distance of 16 mm was scanned to quantify the intrinsic global surface roughness. This roughness is largely determined by the production process (surface condition of the extrusion head). The results of these measurements are presented in figure 2.1.

It is noted that the local surface roughness is smaller than of the global surface roughness due to the production process. The increase in local surface roughness is too small to result in a measurable change in the hydraulic properties of the PVC pipe.

Fig. 2.1 Global surface roughness measurements on soaked and rinsed inner pipe surfaces of the pipes under study (I-VI) measured over 16 mm.

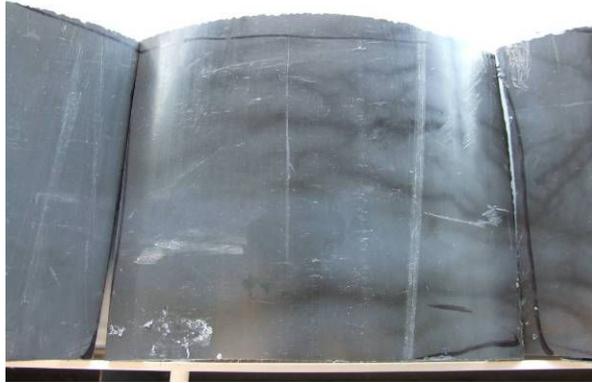
The outer surface of the pipe (code A) shows some stains (see figure A.1). The contours of the stains are almost black. The initial gray colour of the pipes has darkened. This discolouring is ascribed to the interaction of the outer pipe surface with chemicals in the ground water flowing over the outer surface.

The thickness of the degraded layer was less than 100 µm. The thickness of the severely discoloured layer was limited to a depth of the order of magnitude of 10 µm¹. The properties of the discoloured layer seem to be intact. As a result of the limited thickness of the discoloured layer, the mechanical properties of the pipe will not be affected.

Fig. A.1 Stained pattern on outer pipe wall.

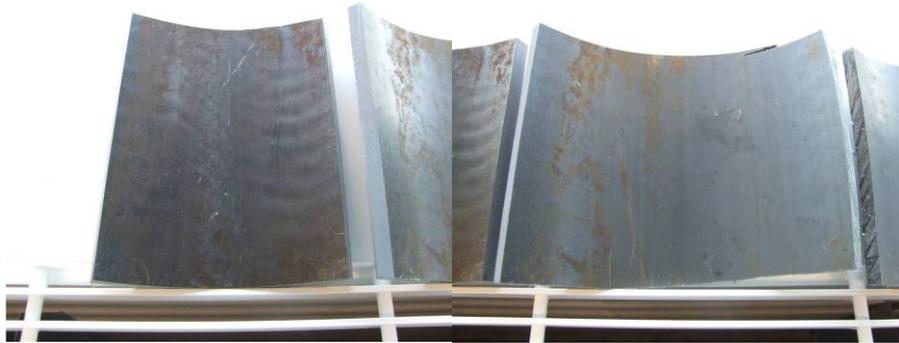
Fig. A.2 Inner surface pipe wall of some parts.

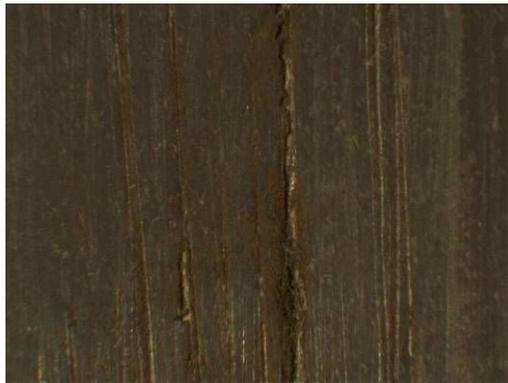
Almost all inner wall surfaces studied showed characteristics of wear. The upper PVC surface layer seems to be grinded. Surface crazes, which might have been present in the inner wall surface, can be removed by this grinding process. The advantage of the removal of the crazes is that the crack resistance of the pipe increases.

Fig. A.3 Inner wall surface; wear tracks in the length direction of the pipe (shown surface: ca. 10x10 mm).

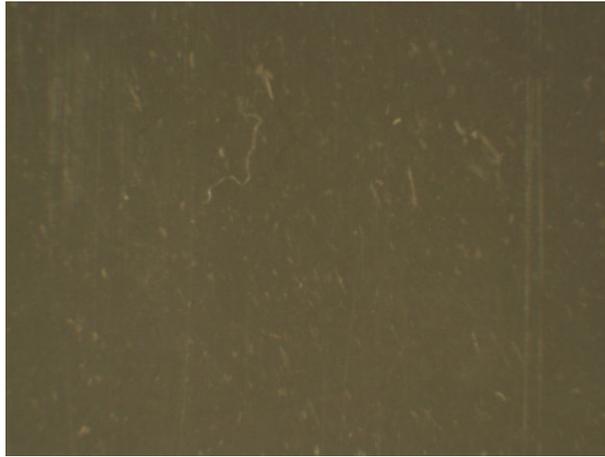
The surface damages indicated as craze are very small. It was not possible to be conclusive on crazes. It is stated that provided that these damages are crazes, no craze growth have occurred.

Fig. A.4 Inner wall surface; small damages and craze (shown surface: ca. 10x10 mm).

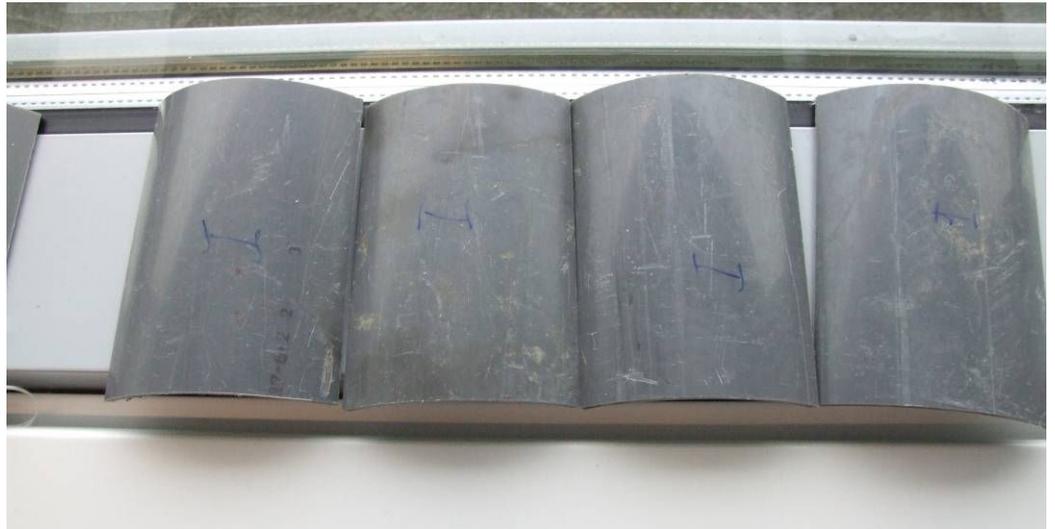
Fig. I.1 Outer pipe wall.

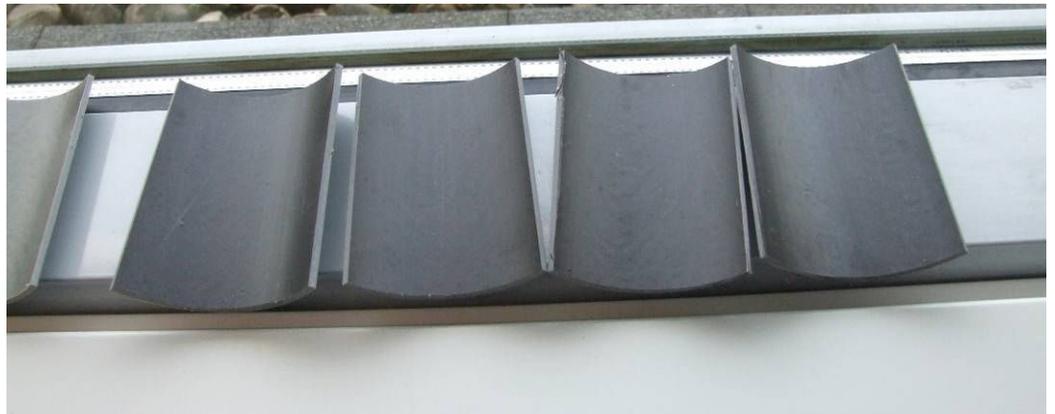
Fig. I.2 Inner pipe wall.

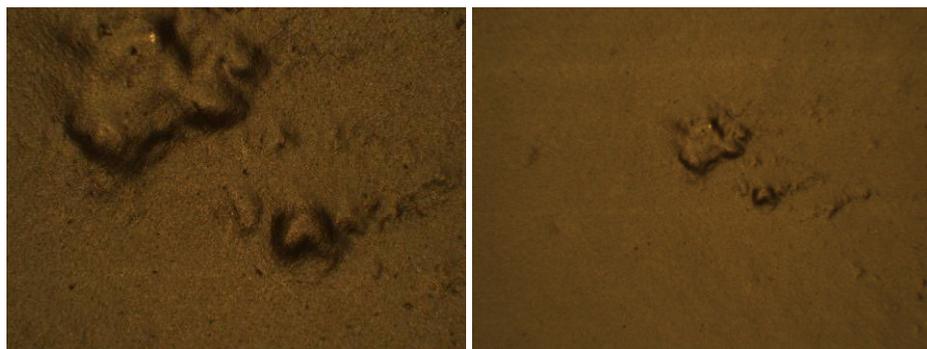
The non-smoothness of the pipe segment code I is ascribed to the production process. It is very unlikely that this surface condition is caused by sewage.

Fig. I.3 Surface inner pipe wall; non-smoothness ascribed to production process (shown surface right: ca. 10x10 mm; left: magnification 6x right photograph).

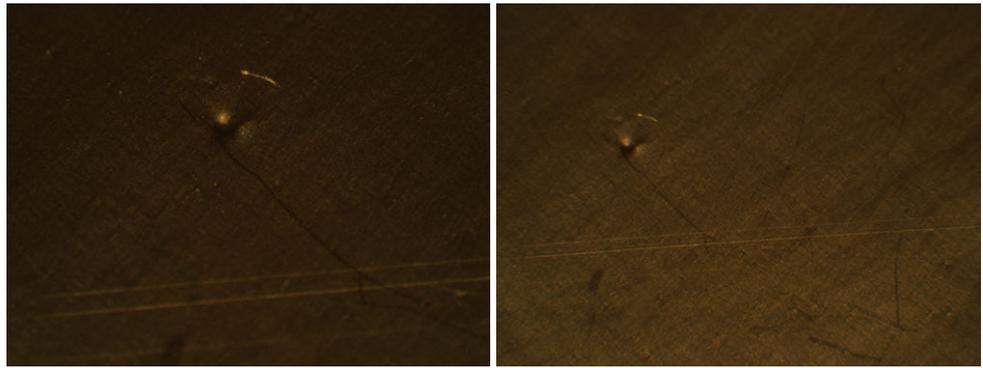
Fig. I.4 Surface inner pipe wall; non-smoothness ascribed to production process (shown surface right: ca. 10x10 mm; left: magnification 6x right photograph).

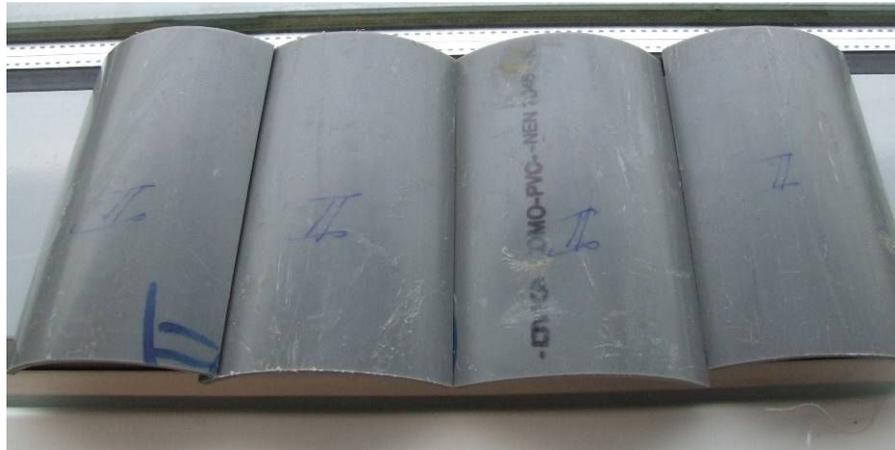
Fig. II.1 Outer pipe wall.

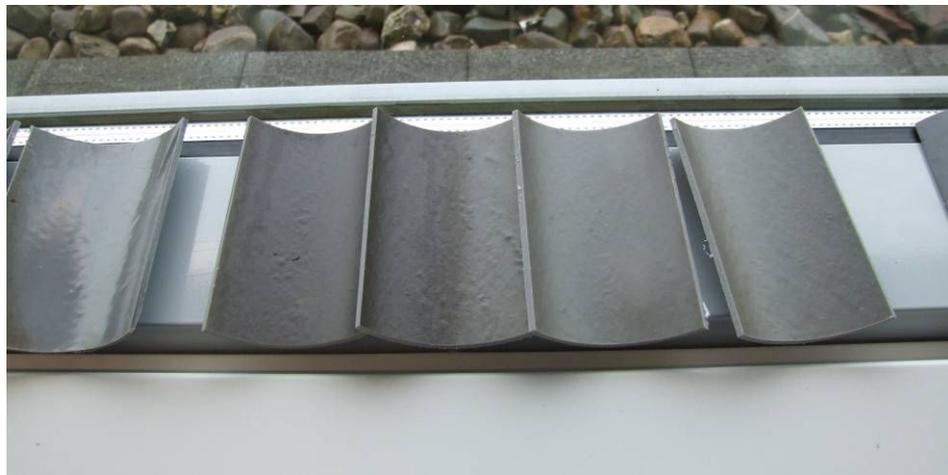
Fig. II.2 Inner pipe wall.

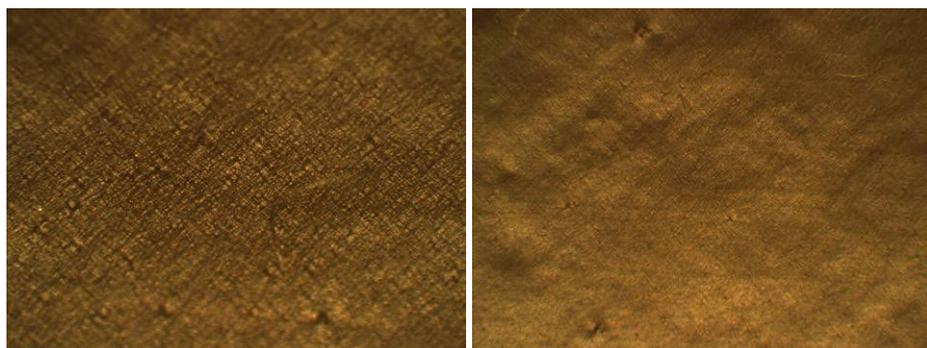
Fig. II.3 Surface inner pipe wall; non-smoothness ascribed to production process (shown surface right: ca. 10x10 mm; left: magnification 6x right photograph).

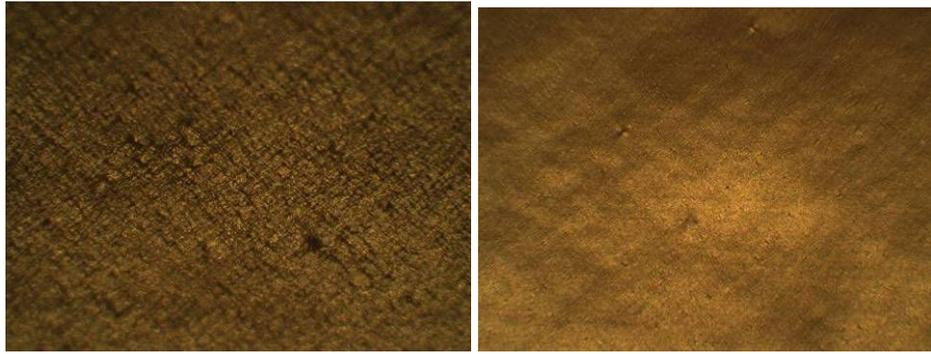
Fig. II.4 Surface inner pipe wall; non-smoothness ascribed to production process (shown surface right: ca. 10x10 mm; left: magnification 6x right photograph).

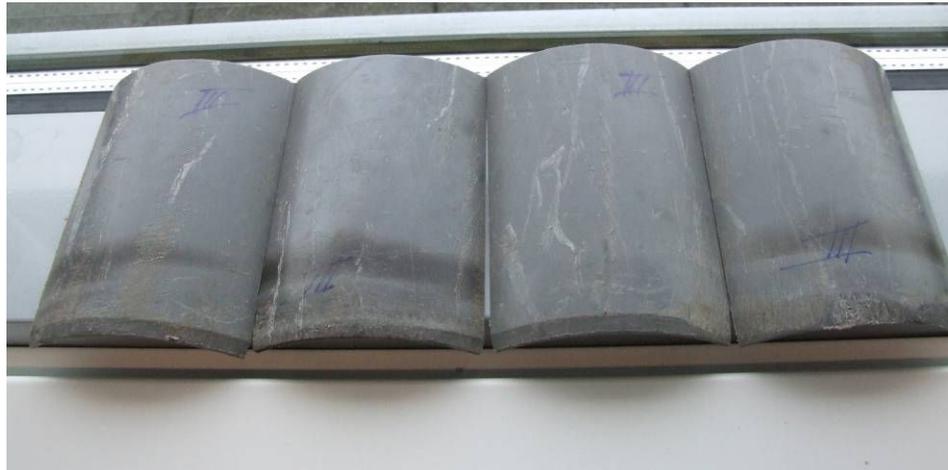
Fig. III.1 Outer pipe wall.

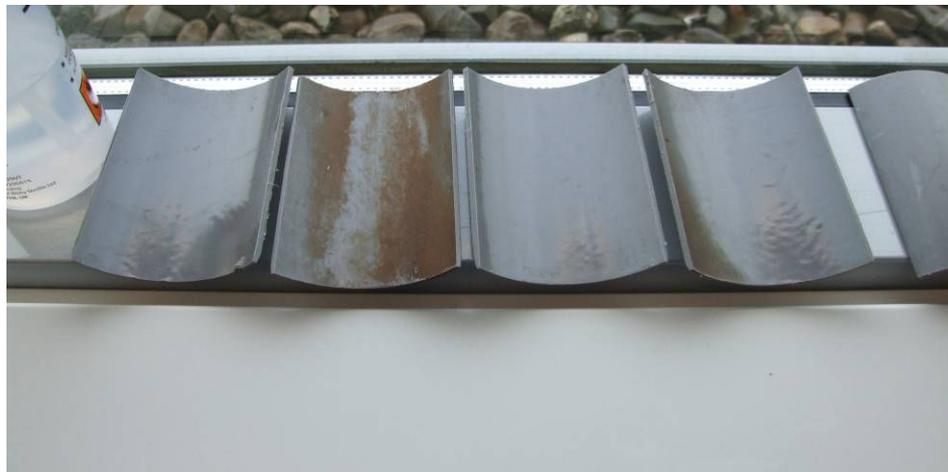
Fig. III.2 inner pipe wall.

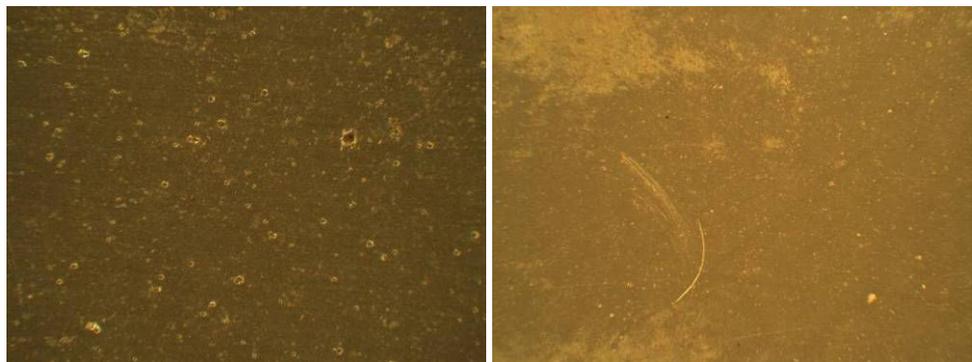
Fig. III.3 Surface inner pipe wall (shown surface right: ca. 10x10 mm; left: magnification 6x right photograph).

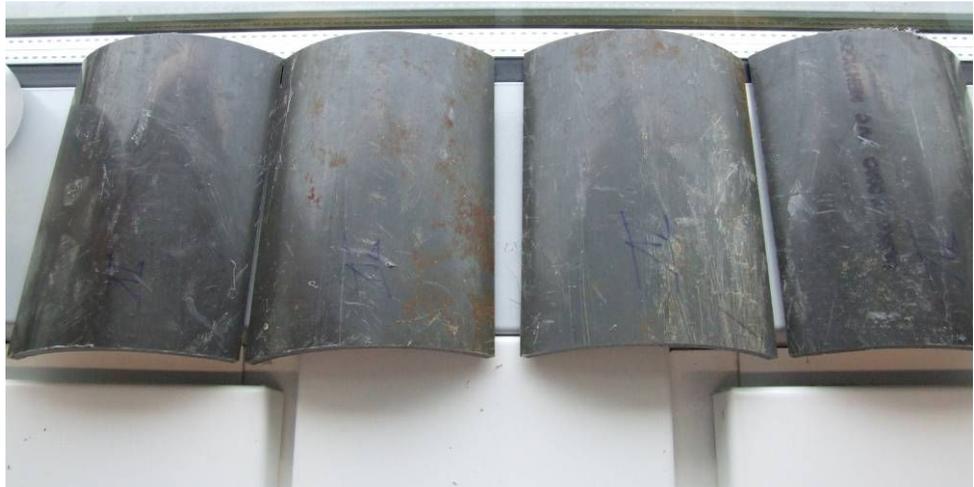
Fig. IV.1 Outer pipe wall.

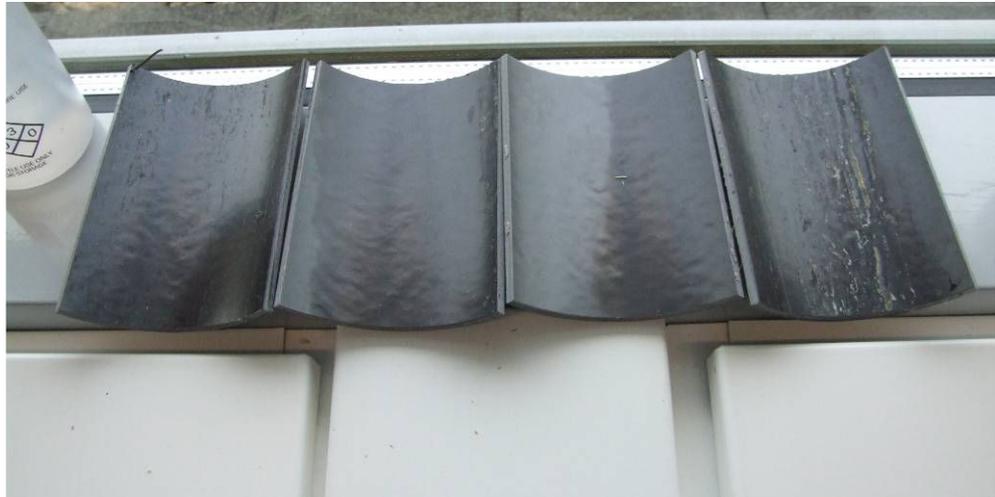
Fig. IV.2 Inner pipe wall.

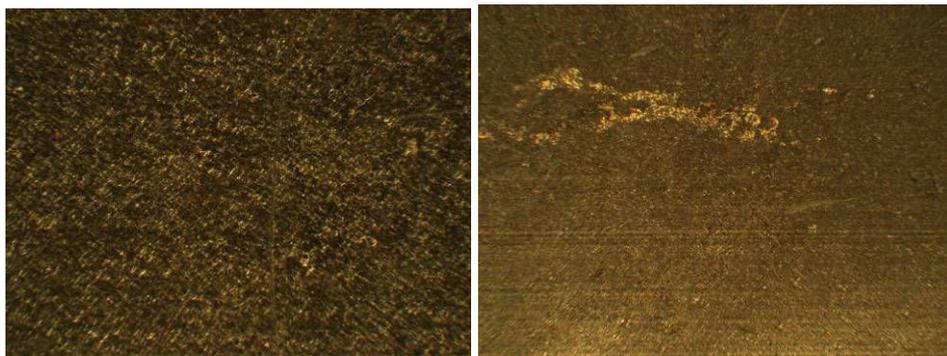
Fig. IV.3 Surface inner pipe wall; remainder of sewage sediment (shown surface right: ca. 10x10 mm; left: magnification 6x right photograph).

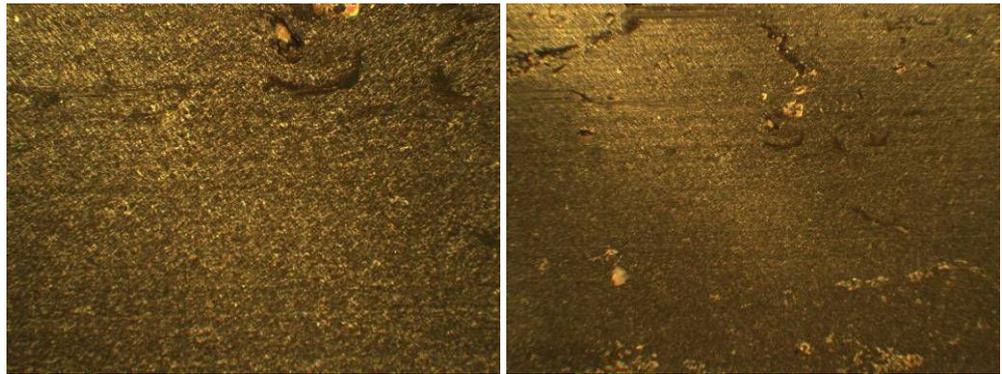
Fig. IV.4 Surface inner pipe wall; remainder of sewage sediment (shown surface right: ca. 10x10 mm; left: magnification 6x right photograph).

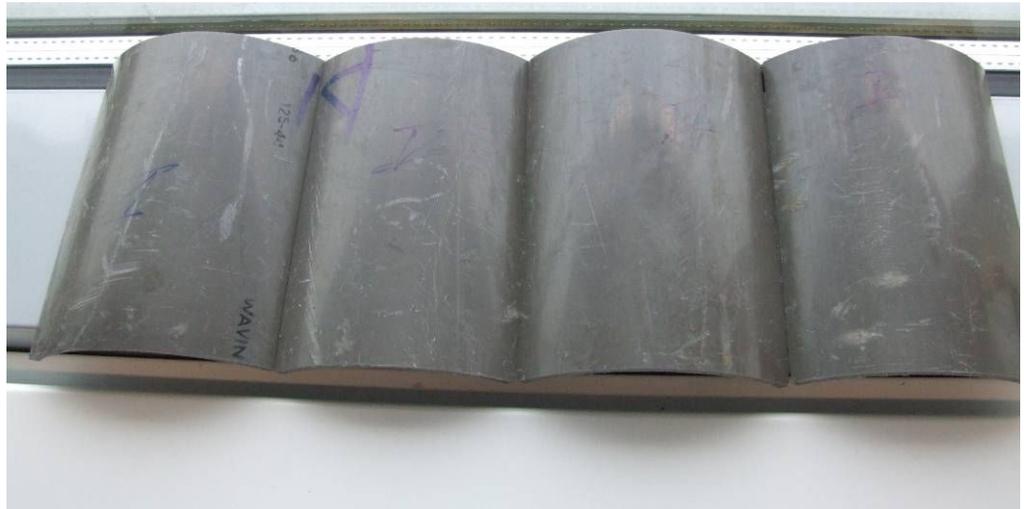
Fig. V.1 Outer pipe wall.

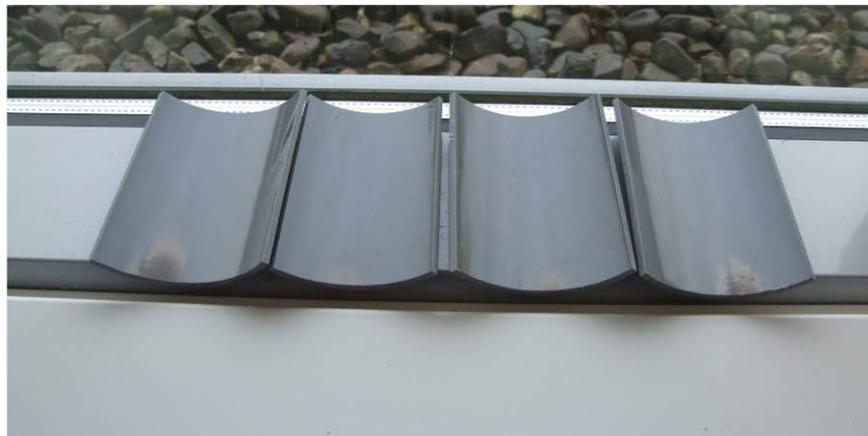
Fig. V.2 Inner pipe wall.

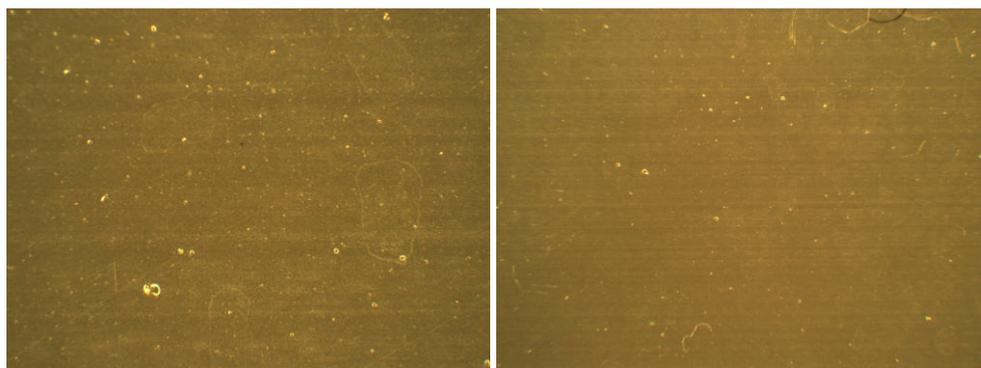
Fig. V.3 Surface inner pipe wall (shown surface right: ca. 10x10 mm; left: magnification 6x right photograph).

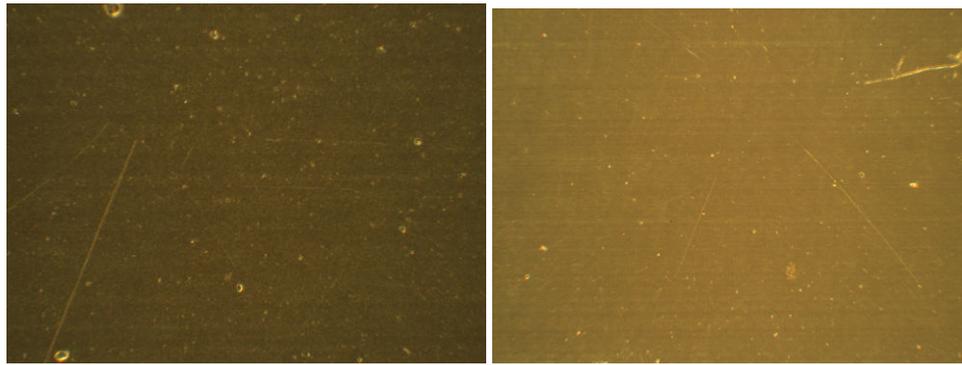
Fig. V.4 Surface inner pipe wall (shown surface right: ca. 10x10 mm; left: magnification 6x right photograph).

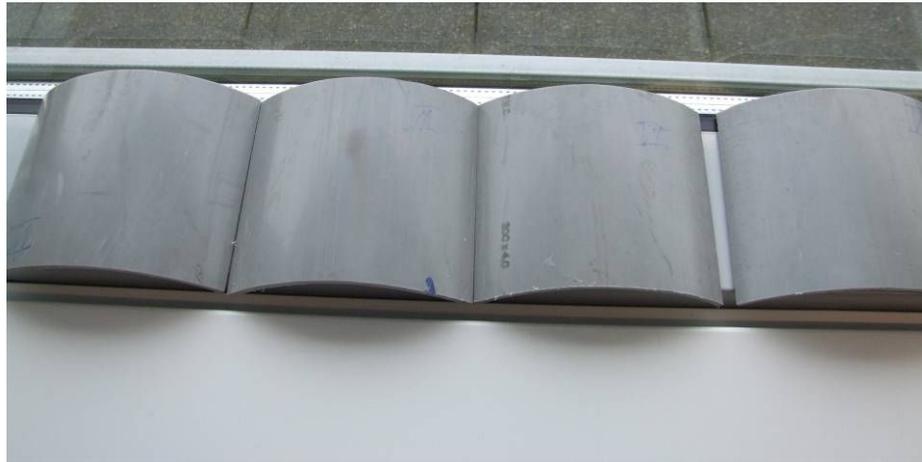
Fig. VI.1 Outer pipe wall.

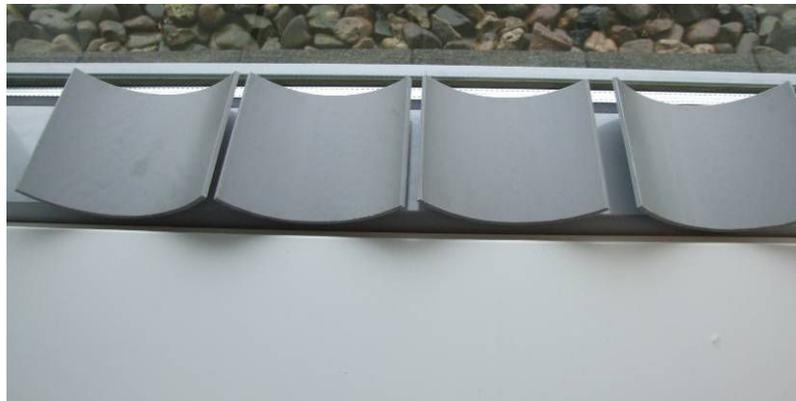
Fig. VI.2 Inner pipe wall.

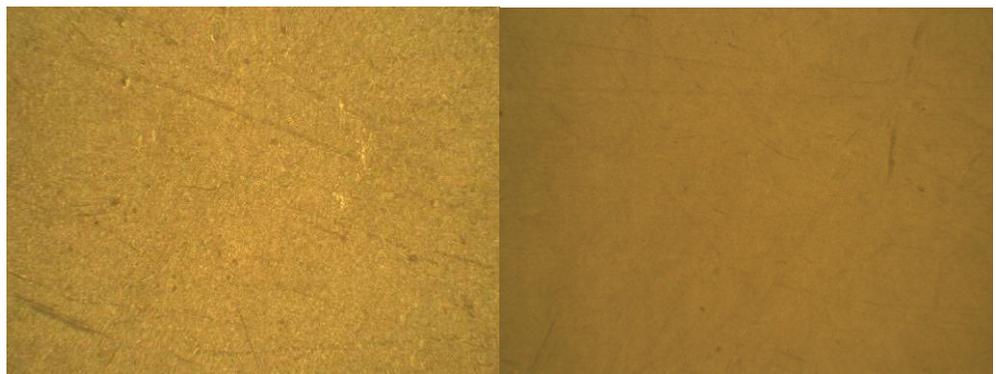
Fig. VI.3 Surface inner pipe wall (shown surface right: ca. 10x10 mm; left: magnification 6x right photograph).
